INSTALLATION RESTORATION PROGRAM

PHASE I - RECORDS SEARCH

AIR FORCE PLANT 78
BRIGHAM CITY, UTAH

MARCH 1984

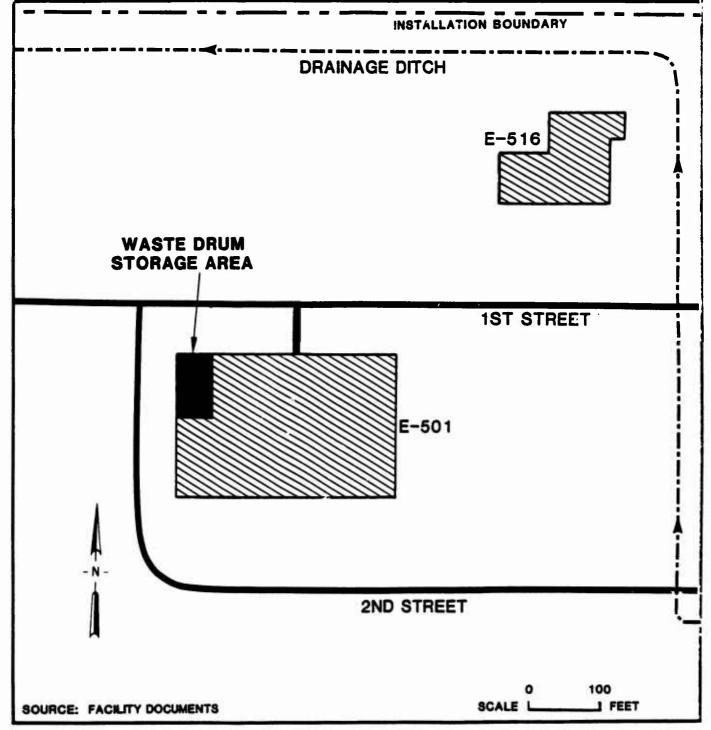
HAZARDOUS WASTE STORAGE AREA

Since 1980, storage of hazardous wastes at Plant 78 has occurred at one location as shown in Figure 4.1. This facility serves as a storage area for several items and is used to store recoverable methyl chloroform waste solvent. The recoverable solvent is sold to a contractor for reuse. Prior to 1980, the recoverable methyl chloroform was stored off of Plant 78 property awaiting sale to a contractor. All non-recoverable hazardous chemical wastes have been taken off-plant for Morton Thickol disposal.

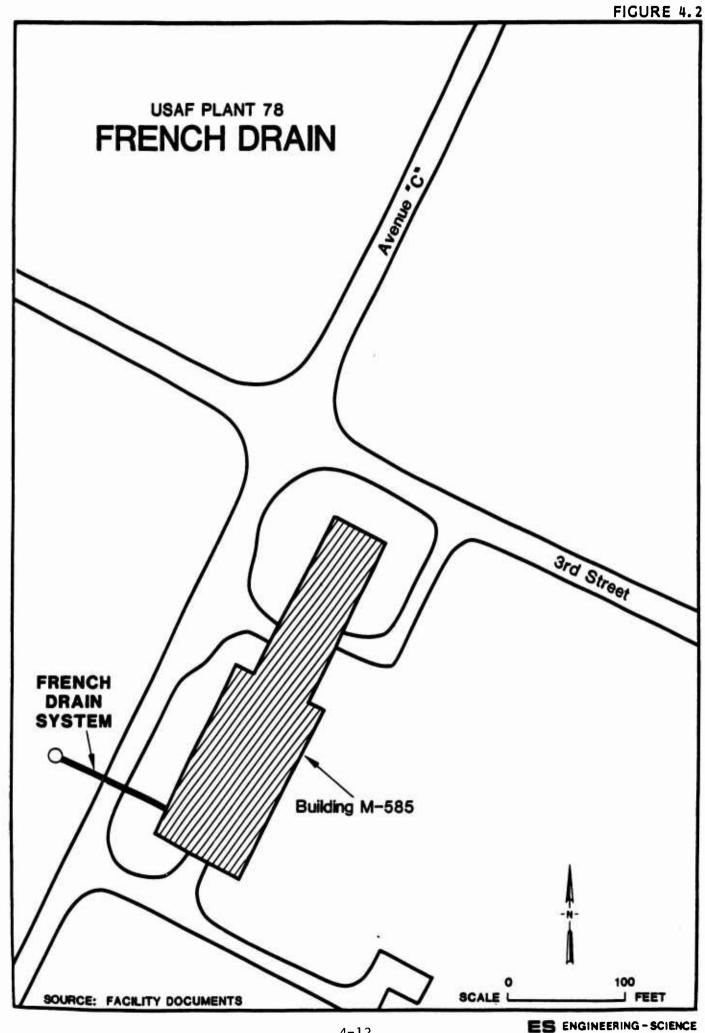
A french drain is located at Building M-585 as shown in Figure 4.2. The french drain consists of a 4-inch diameter gravity-flow line from the southwest end of Building M-585 leading to a large diameter subsurface pit which allow water to seep into the soil. In the past, this french drain has received quantities of sink rinsewater contaminated with acids, alkalies and various solvents including acetone, MEK and benzene. Since 1980, disposal of solvents in the french drain has been eliminated and acids and alkalies are neutralized and/or diluted prior to disposal in the french drain. Waste solvents are presently segregated for off-plant disposal.

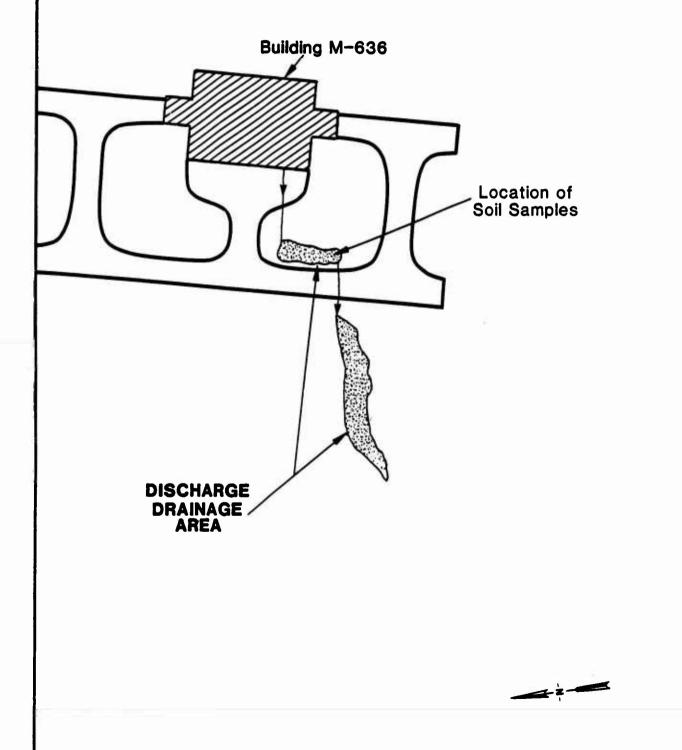
X-O-Mat Wastewater Discharge Area No. 1 (Bldg. M-636)

Photographic waste solutions containing silver and possibly cadmium were discharged from Building M-636 from the 1960's through 1982. The discharge area is shown in Figure 4.3. The area is a drainage path whereby the effluent from X-ray processing equipment was allowed to run onto the ground after some silver recovery. It would then evaporate or seep into the ground. In 1982, the fixer solution which contains the silver has been separated from the waste streams and collected for high efficiency silver recovery at Building M-508. The discharge of non-silver bearing photographic wastes was diverted to a separate drainage area and some attempts to recover the silver contaminated soil have been made.

Soil samples were taken from the locations shown in Figure 4.3 to determine the total silver content and the potential leaching properties of the silver in the soil. The results of the sampling are shown in Table 4.3. The data indicates that the total silver content of the soil is approximately 25 percent by weight; however, the EP toxicity values indicated a range of 2.48 ppm near Building M-636 and 0.30 ppm away from Building M-636.
